Impact Sensor - Experimental Arrangement

IMPACT SENSOR TEST ARRANGEMENT
 R H BROWN 10.03.00

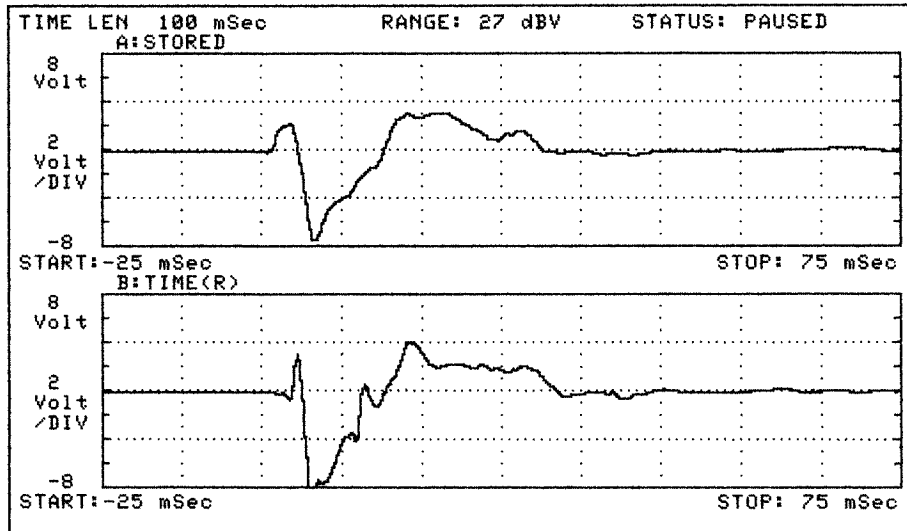
FIG ②: SINGLE SENSOR, 1M Ω

JUST MISS

JUST HIT

Using the x100 probe, the time constant of the measurement is approximately 120 ms (for single sensor case), and therefore the recorded waveform can be assumed to be quite close to the true strain signal. The moment of contact with the cylindrical tape roll can be seen as a very small "step" superimposed on the slower, high-amplitude signal from the general stretching of the fabric. Using x1 arrangement, the time constant is reduced by a factor of 100, to 1.2 ms, and therefore the waveform gives almost a differentiation with respect to time. The contact is seen as a "glitch" in the waveform, but is still rather hard to detect.
